Site 348 Atlantic Breeze Condominiums

Great Marsh Coastal Wetlands Restoration Plan
Rapid Technical Assessment Site 348

Site 348: Atlantic Breeze Condominiums, Salisbury, MA

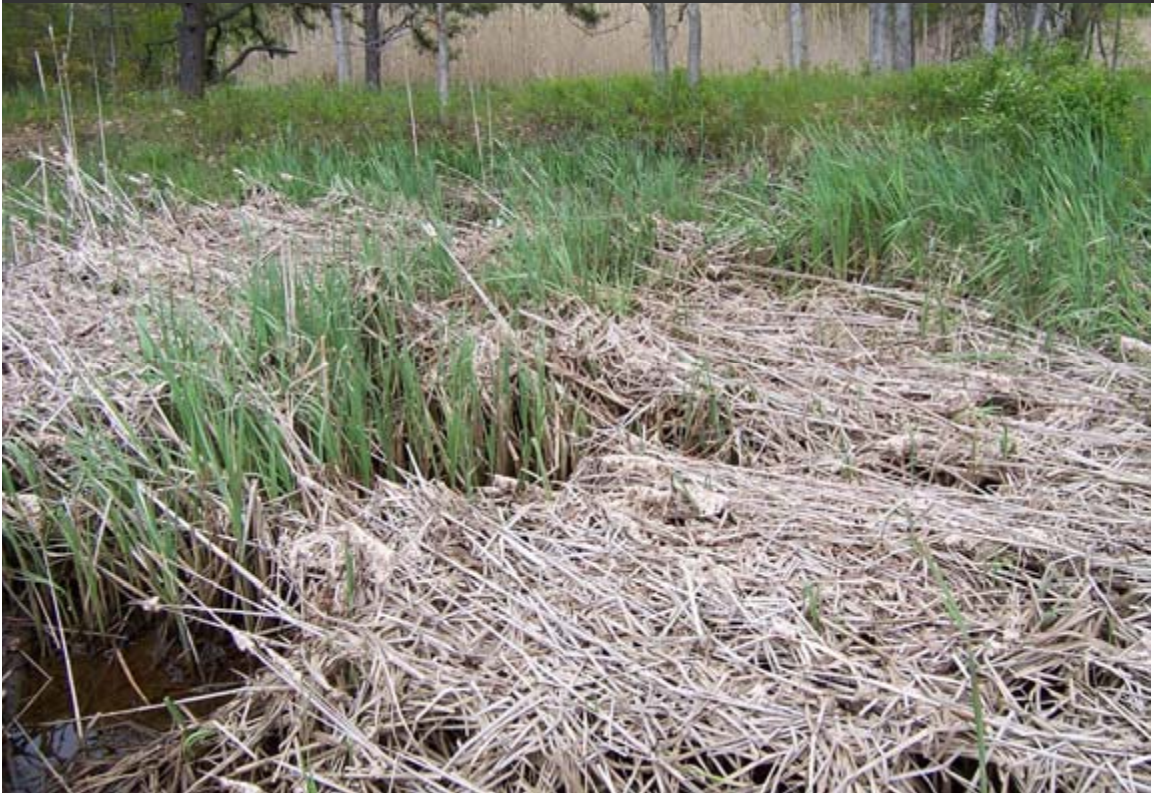
Structure conditions: The existing berm is approximately 4 ft in height and 8 ft in width. It is generally well vegetated with small trees but shows some signs of erosion from past storm events. Overall the berm is in fair condition. The single culvert through the berm consists of a 22 ft long, 12 in diameter cast iron pipe. There are no headwalls or scour protection at the culvert ends, however, no signs of scour were observed. Tidal flow into the culvert would be enhanced with the maintenance of the ditch below the berm. The culvert is in fair overall condition. The outlet of a recently installed water quality structure (Vortech) discharges into the wetland just upstream of the berm. The original function of the berm is unknown.

Photo 1 - View of Berm and Restricted Marsh Beyond

Overall, the existing impairments are considered severe. Removal of a portion of the berm within the condominium parcel along with maintenance and/or cutting of additional ditches would reduce the tidal restriction during larger tide events and reduce the impounded conditions which likely further reduce salinity levels within the potential restoration site. These measures could dovetail with the currently permitted herbicide control measures to reduce *Phragmites* coverage within the restoration area. These steps will also reduce the fire safety hazard associated with *Phragmites* and improve fish foraging habitat. The surrounding development was constructed above the elevation of the predicted 100-year flood so there are no low-lying property concerns.

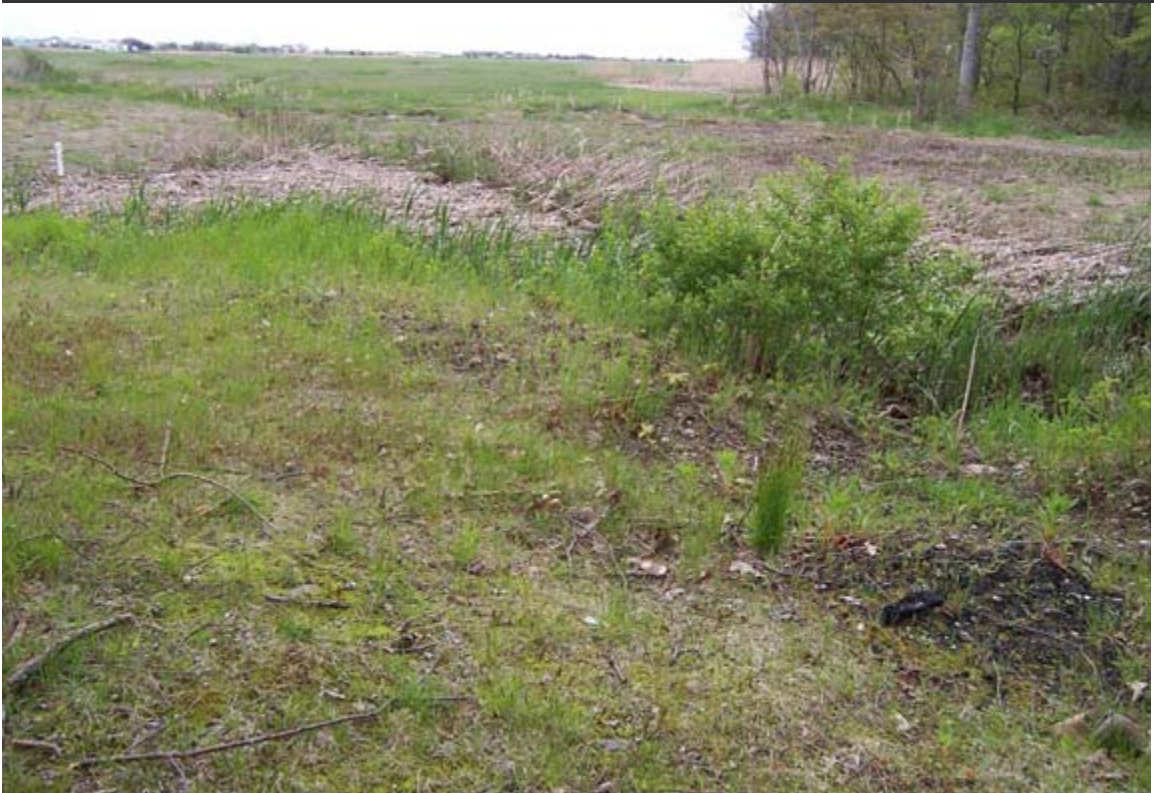
Based on biological benchmark data, the potential restoration site lies slightly below the elevation of the adjacent healthy high marsh downstream of the berm (approximately 0.2 ft). However, there are several brackish species also present in the marsh just downstream of the berm, as well as several nearby fringing stands of *Phragmites* adjacent to the unrestricted salt marsh. These areas appear to be associated with zones of freshwater discharge from adjacent uplands.

Photo 2 - Marsh Downstream of Berm

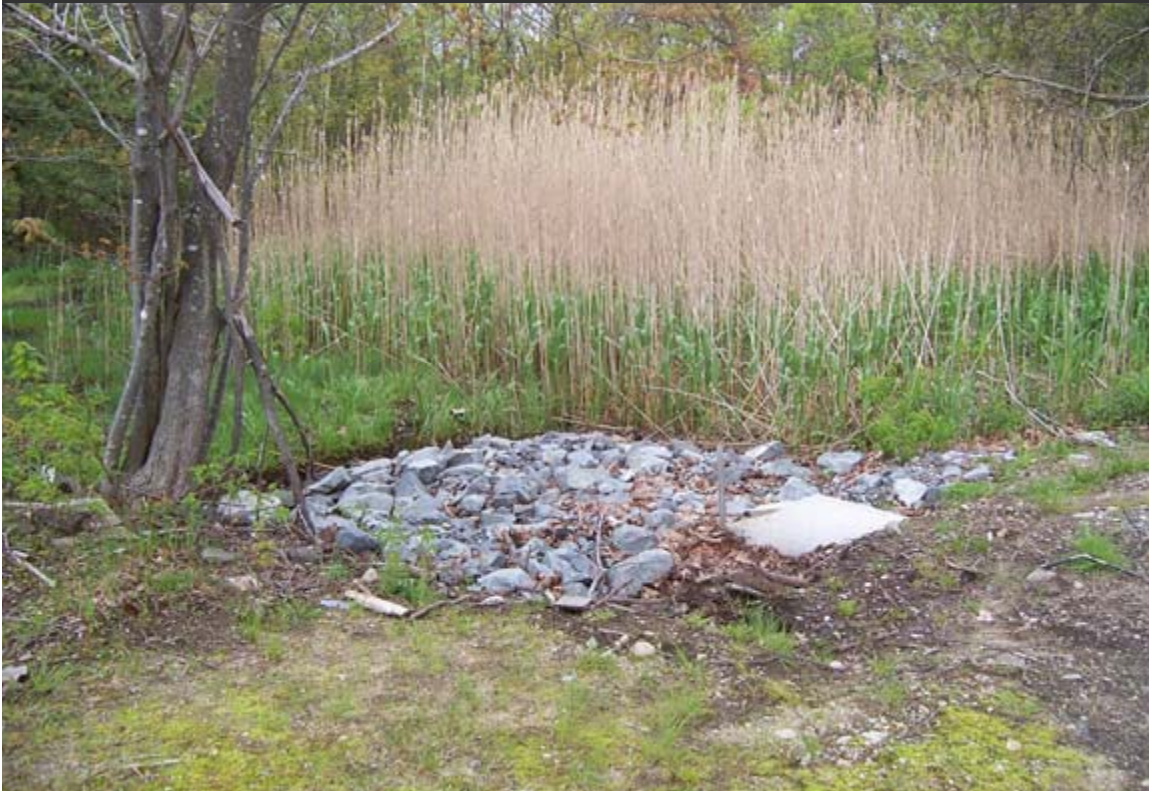
Ecological Integrity: The potential restoration site generally has a low level of ecological integrity. The emergent wetland is dominated by a vigorous stand of *Phragmites*. The potential restoration site currently receives a substantial volume of stormwater from the adjacent condominium development. However, the stormwater management within the development incorporates several BMP's including deep sump catch basins, treatment swales and a Vortech water quality structure. While the stormwater management plan provides some treatment and controls the rate of runoff into the wetland, the total volume of freshwater entering the wetland has likely increased with the new development. The Condominium has received an Order of Conditions from the Salisbury Conservation Commission to control *Phragmites* with

Photo 3 - *Phragmites* Upstream of Berm

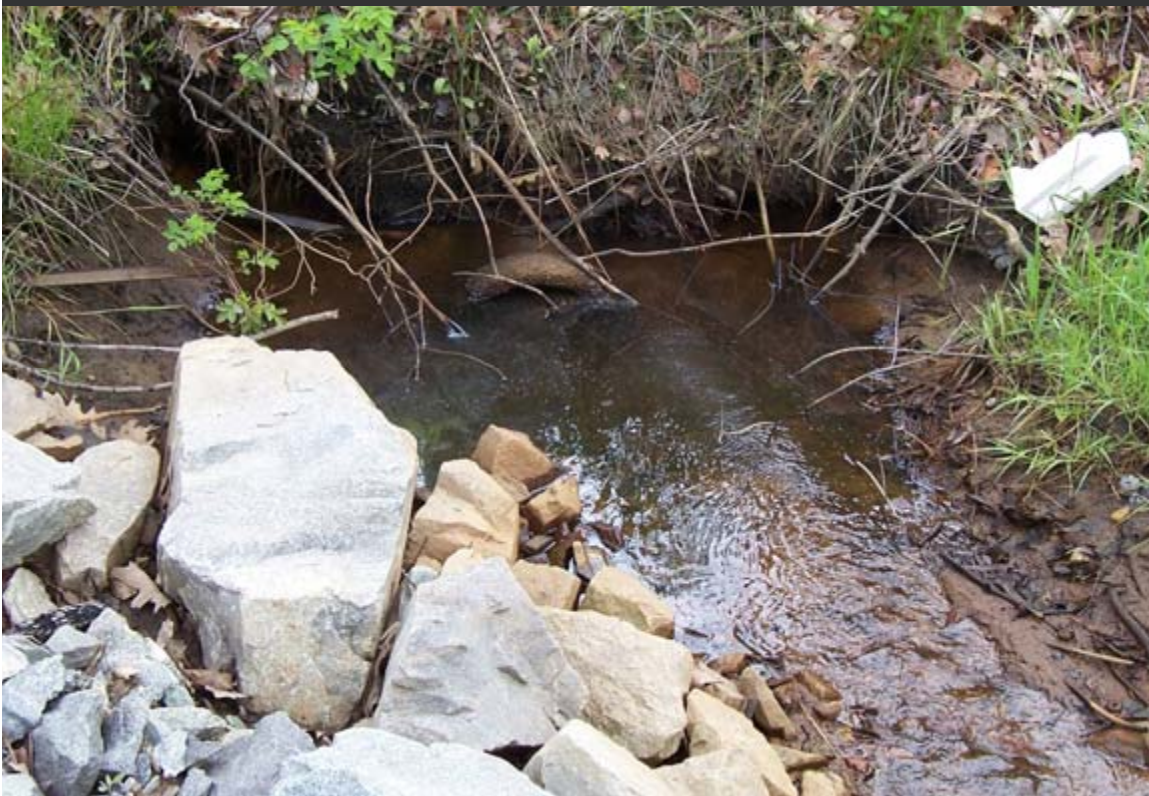
Photo 4 - Upstream View of Culvert Under Berm

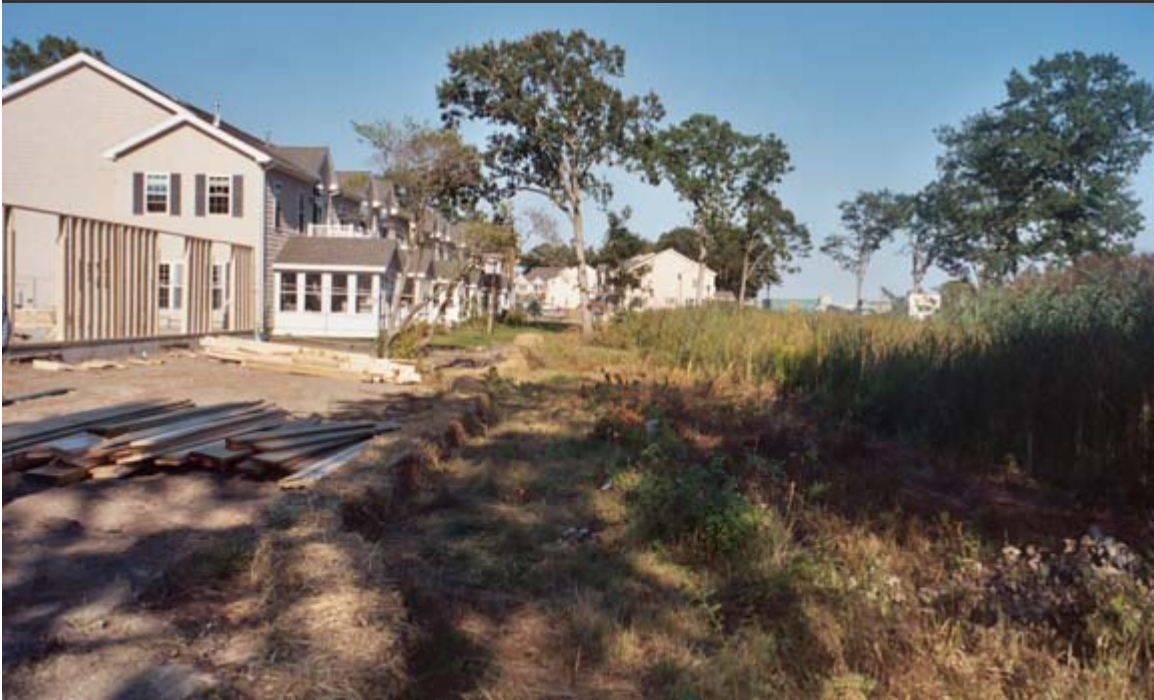
Photo 5 - Redevelopment Adjacent to Restoration Area

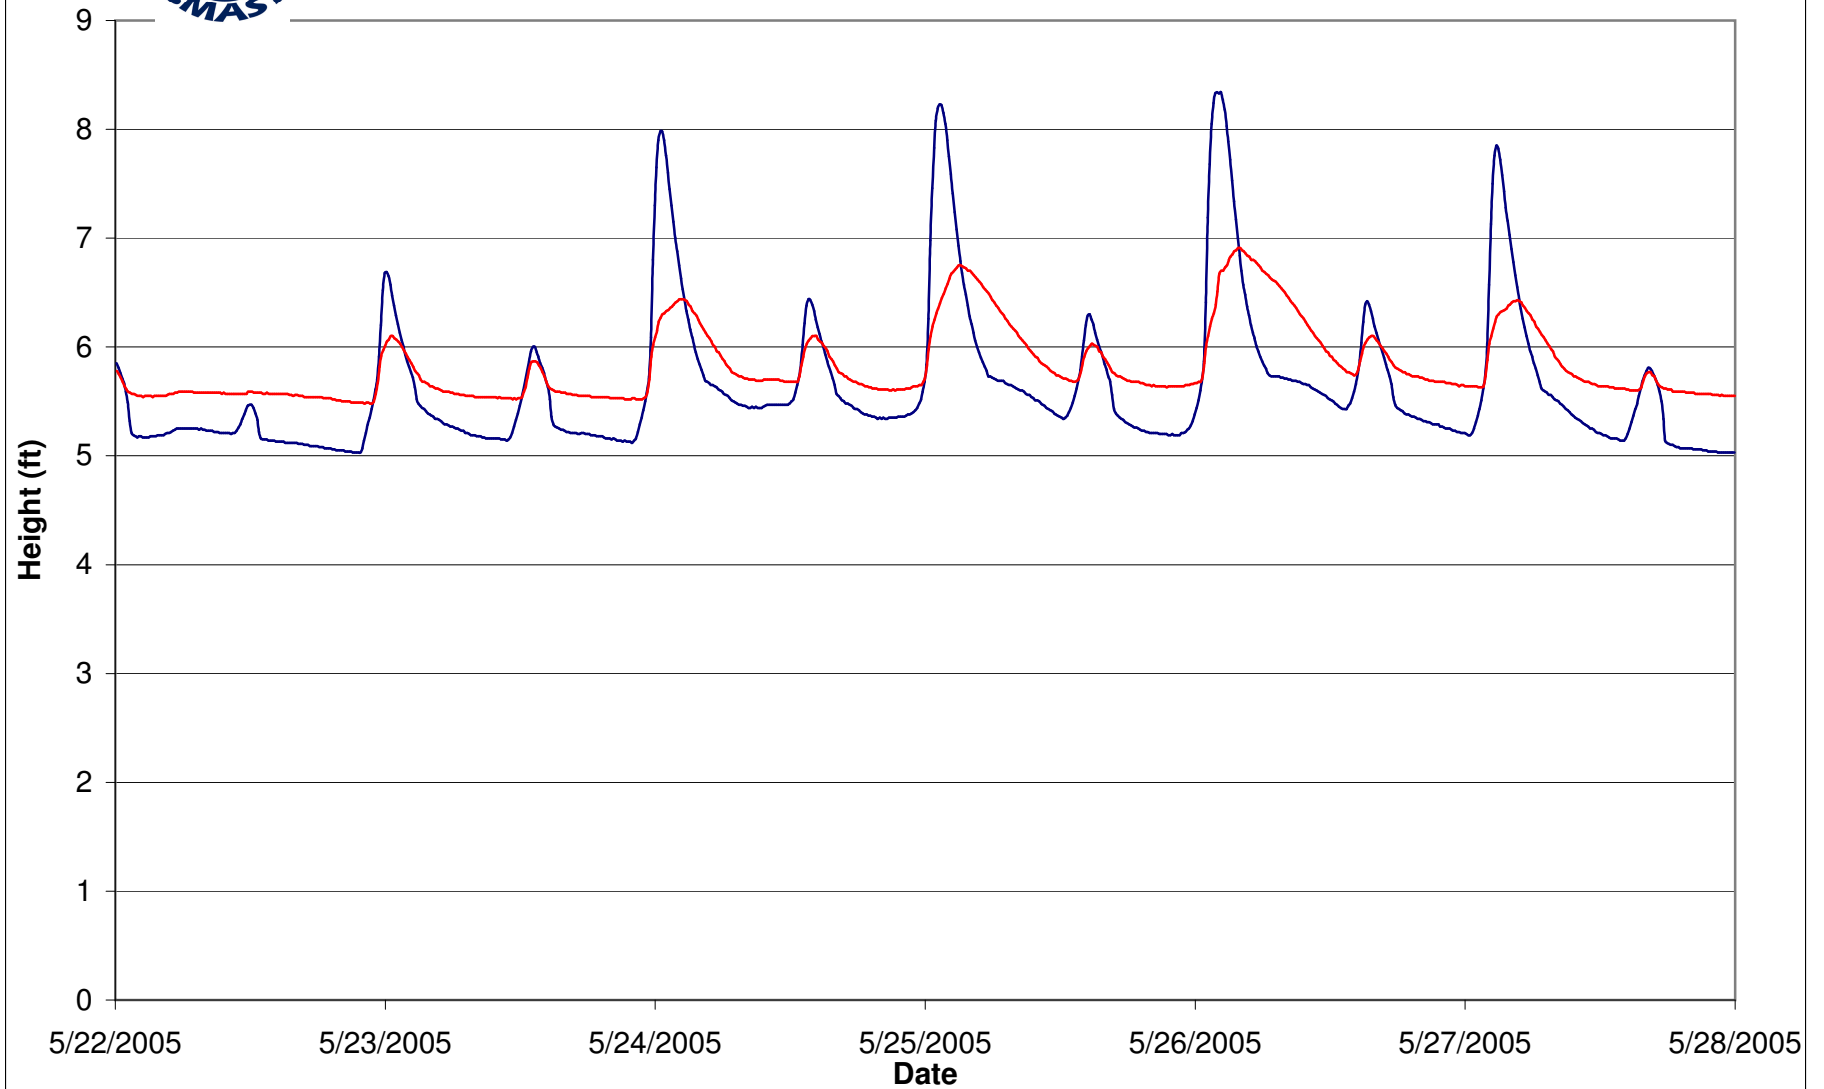
Down Stream
Up Stream

Two tide gauges were deployed from May 18 to June 2, 2005 upstream and downstream of the culvert under the berm. There were a total of 23 tidal cycles recorded downstream of the culvert during the deployment period. Results of the deployment show that there is a significant restriction of tidal flow through the culvert to the upstream portion of the marsh during large tidal events. The total tidal prism of the marsh creek downstream of the culvert is more than 3 ft. The tidal prism upstream of the culvert varies from 0 to approximately 1.5 ft. The gauge upstream of the culvert recorded a tidal prism on 16 of the 23 tidal cycles, when the tide height downstream was 5.50 ft or higher. The highest tide downstream of the culvert was recorded during a major coastal storm on May 26 at 1:57 AM. The NGVD adjusted height was 8.34 ft. The upstream adjusted height was 6.91 ft and occurred at 3:49 AM. The restriction caused a tidal dampening of 1.43 ft upstream of the culvert and a delay of 1 hr 52 minutes. The largest measured tidal dampening of 1.54 ft occurred on May 24th. This dampening amounted to approximately 57.0% of the total tidal prism recorded at the downstream gauge. When tidal heights are high enough, there is both a significant dampening and delay of tidal flow into the restricted marsh. The lack of a creek system within the restoration area, as well as impeded flow within the ditch below the berm, resulted in the impoundment of water during a large portion of the deployment period. The impounded water within the restoration area was likely runoff from the surrounding developments.
